Date: November 2, 2012  
Project No.: 118-37-2

Re: Geotechnical Feasibility Study  
Samsung Semiconductor Corporate Headquarters  
3655 North 1<sup>st</sup> Street  
San Jose, California

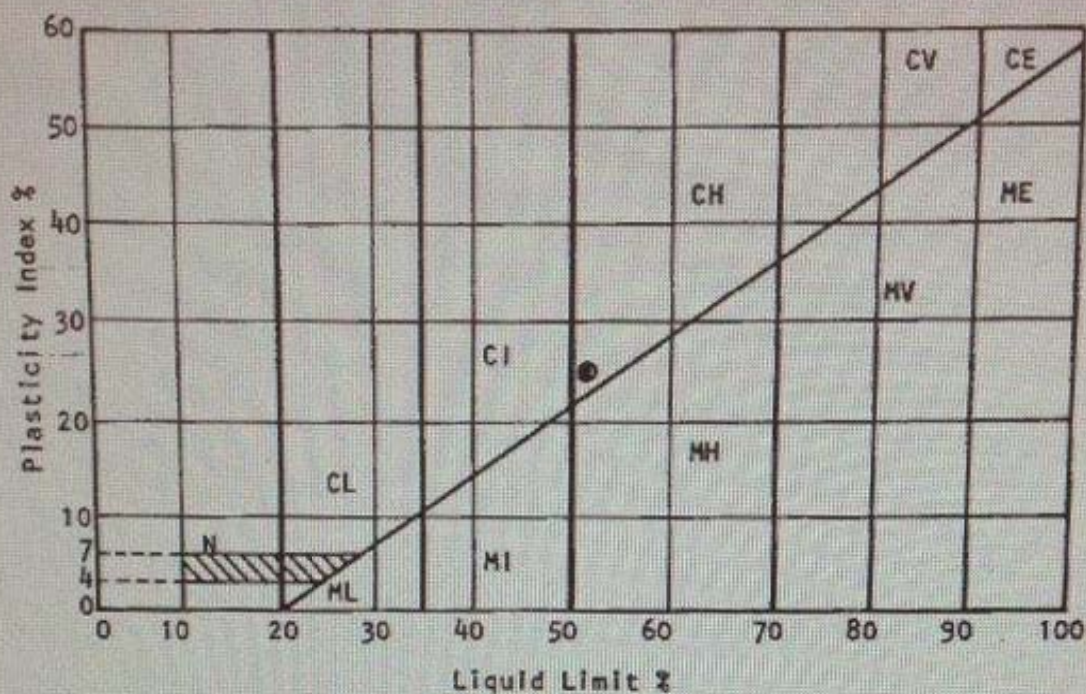
## PLASTICITY CHART

## PLASTICITY DATA

Key Symbol	Hole No.	Depth Ft.	Liquid Limit %	Plasticity Index %	Unified Soil Classification Symbol*
o	BAG "A"	1-1.5	51.4	24.3	CH

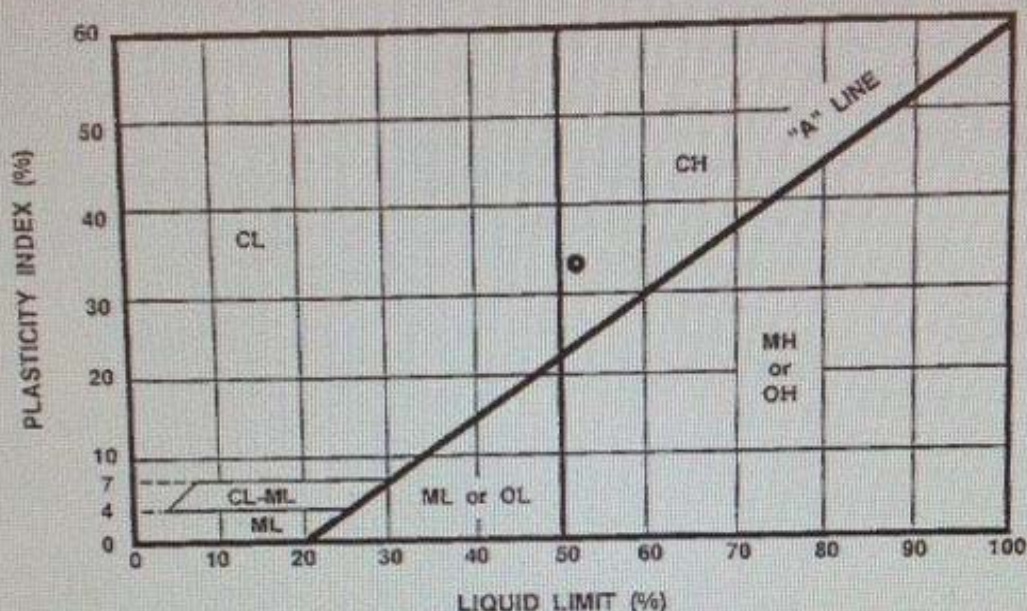
KEY SYMBOL	BORING NUMBER	SAMPLE DEPTH (Feet)	NATURAL WATER CONTENT (%)	LIQUID LIMIT (%)	PLASTICITY INDEX (%)	PASSING No. 200 SIEVE (%)	LIQUIDITY INDEX	UNIFIED SOIL CLASSIFICATION SYMBOL
●	EB-2	5	20	52	33	87	--	CH
